Department
of Commerce

Historical Boiler Licensing Board

Leakage Through Fusible Plugs

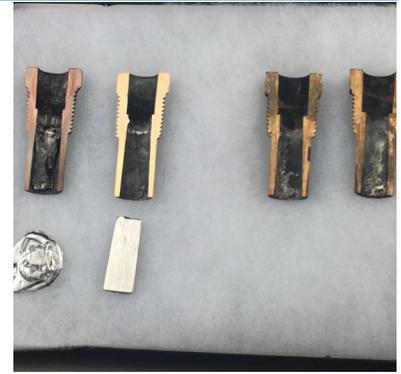
The danger of leakage through fusible plugs still exists today. Figure 1 shows two fusible plugs that were found to be leaking. The plug on the right was installed in a steam traction engine, and was removed after the owner experienced water dripping on him when working in the firebox. This plug replaced a previous one that was removed for the same reason. The bore of the casing had been only partially tinned. The plug on the left shows another fusible plug that was removed from a locomotive for the same reason. This plug shows no signs of having been tinned. These two plugs are from two different manufacturers.

The Board agrees with the findings of the Steamboat Inspection Service’s stipulation from 1930, and advises, *“If there is at any time any evidence of a leak, the plug should be immediately replaced.”* A simple impact test, prior to installation, might also be a good idea.

Any leaking fusible plug should be brought to the attention of the state inspector or a member of the board.

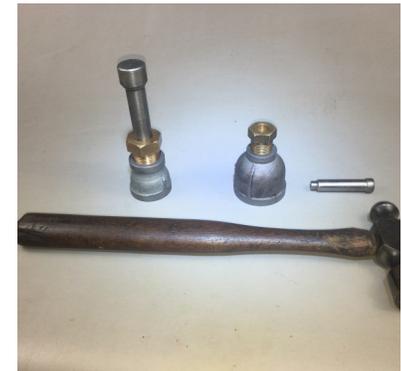
Figure 2

Their conclusions included a recommendation that an impact test be used to evaluate the tightness of the filling in a plug. This test, shown in Figure 2, could be as simple as “... striking the small end with a punch and hammer.” But to ensure greater uniformity, they recommended dropping a 2-pound weight through a distance of 6-inches onto the small end of the filling. The device for doing this is shown in Figure 3. It is not known what test the manufacturers are using today. The A. S. M. E. Code does not include any mandatory requirements for the construction of use of fusible plugs.
